# AN ARCHEOLOGICAL RECONNAISSANCE AND HISTORIC STRUCTURES ASSESSMENT AT SEVEN U.S. COAST GUARD INSTALLATIONS IN FLORIDA

Susan E. Garrett

1984

Archeological Services Branch National Park Service Atlanta, Georgia

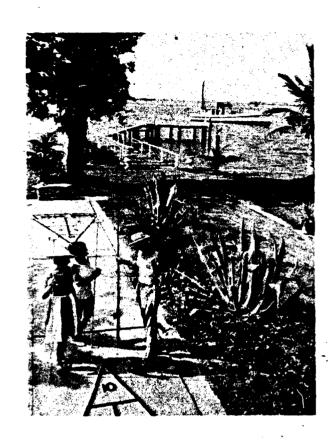
Following purchase by the Coast Guard, extensive renovations to the building and grounds were made. The grounds were largely covered with concrete slabs for parking, and prefabricated outbuildings were added, all of which greatly altered the setting. On the exterior of the old inn, the wood siding was removed and replaced with aluminum siding. The screen porches were removed, the original doors were replaced, sliding glass doors were installed, air-conditioning units were added, and all but one of the wood windows were replaced with alumuninum windows (Figures 7-10). The

Figures 5-6. Views of the Albion Inn as it looked at the time of its purchase by the Coast Guard in 1974.

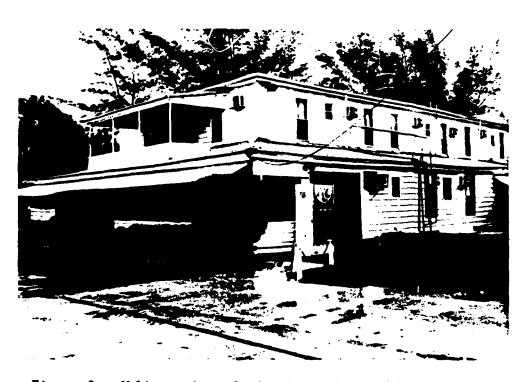
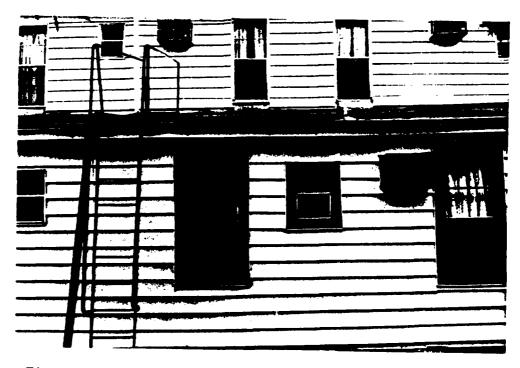
Figure 7. South elevation, administration and barracks building, Station Cortez.

Figure 8. Oblique view of administration and barracks building, Station Cortez.

Figure 9. Entrance to administration and barracks building, Station Cortez.

Figure 10. Aluminum siding, aluminum windows, and air conditioning unit, administration and barracks building, Station Cortez.

interior of the building was also extensively remodeled to make modern office and living space: the original wood staircases were taken out, dropped ceilings were installed, panelling was used to partition old areas, and the kitchen was replaced with a modern messhall kitchen.

Summary and Recommendations. The archeological survey did not reveal any potentially significant cultural properties on Station Cortez. No further archeological investigations are recommended. The historic structure assessment suggested that in light of the extensive interior and exterior modifications, the administration and barracks building, though of local historical interest, no longer maintains the historic character that would make the structure eligible to the National Register. Though the Coast Guard may wish to undertake further research on the historic significance of the building, no further historic structures documentation is required.

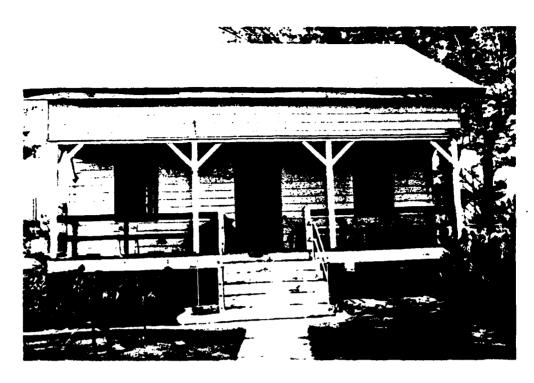
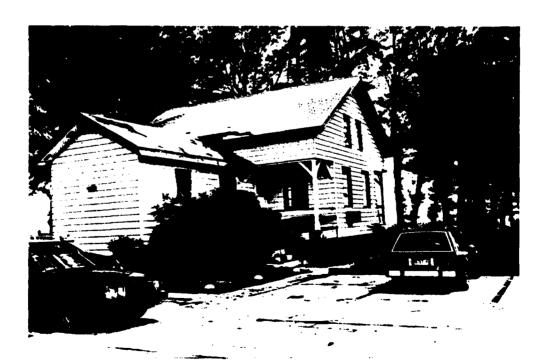
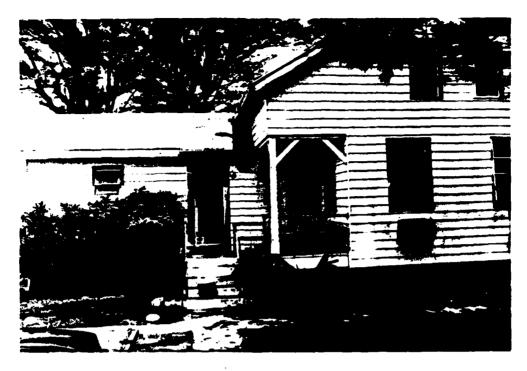
In contrast to the unaltered condition of the lighthouse, the four associated buildings dating to ca. 1907 have been extensively modified. The light keeper's quarters (also known as Quarters 1 and the O.I.C. Quarters) and the senior officers' quarters (also known as Quarters 2 or the V.I.P. Quarters) are recorded in the State files and on the National Register forms as one-story T-shaped white clapboard buildings either having minor alterations or being "virtually unaltered since their construction." In fact, the two buildings, which are identical in design, are two stories high, and they have been extensively modified over the years. At the time of the Park Service survey the exteriors had been covered with aluminum siding, obtrusive air conditioning units had been installed, the

original wood windows replaced by aluminum windows, and the ornamental wood corner braces removed (Figures 15-17). Coast Guard plans for renovating the building call for replacing the aluminum siding with vinyl siding and replacing the present aluminum windows with wood windows which will more closely approximate the original.

Figure 15. South (front) elevation of keeper's cottage, Hillsboro Inlet Light Station.

Figure 16. View of keeper's cottage looking south-southwest, Hillsboro Inlet Light Station.

Figure 17. Partial west elevation of keeper's cottage, Hillsboro Inlet Light Station.

Summary and Recommendations. The archeological suggested that no significant prehistoric or historic sites exist at the Hillsboro Inlet Light Station, and no further archeological investigations are recommended for the facility. The historic structures documentation revealed that the National Register forms were not correct in all aspects and should be amended to include the crews' quarters and shop/garage in the significance statement. The nomination should also be updated to reflect the current condition of the keeper's quarters.

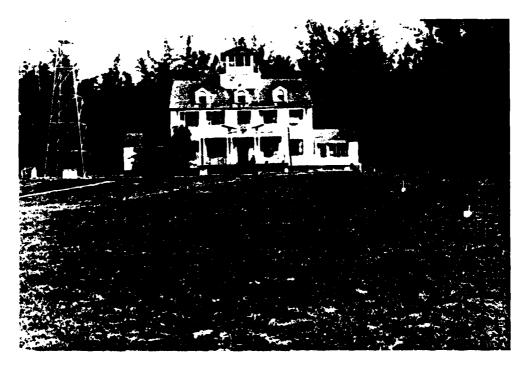
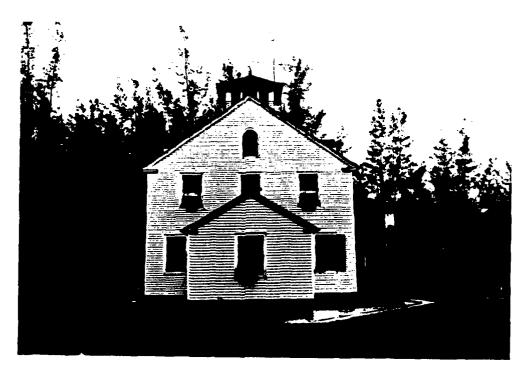
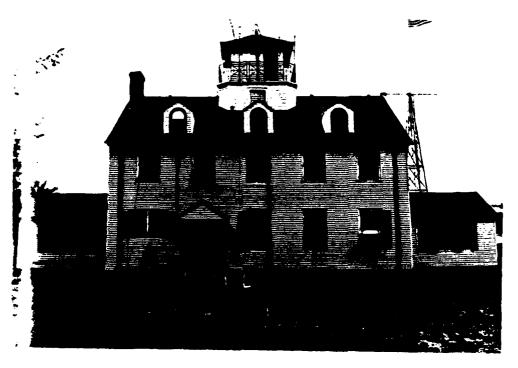
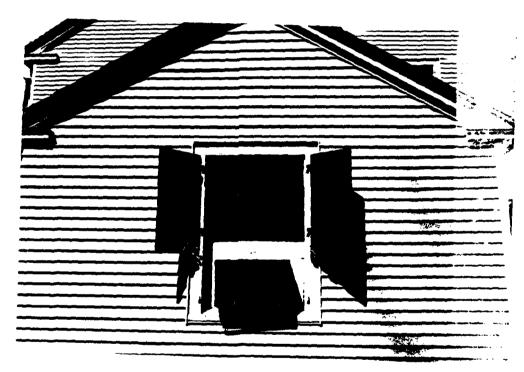
The barracks building is a two-story white frame building with a basement, loft, three front dormers, and a watchroom (Figures 22-25). The exterior has remained relatively unmodified since its construction, except for the addition of white vinyl siding. The interior has been extensively modified, however, to make modern office space, equipment rooms, living areas, a kitchen, and dining area. All original interior architectural details, proportions, and interior spaces have been completely altered. The walls have been covered with panelling, the ceiling dropped, window air conditioning units installed, and rooms divided.

Figure 22. South (front) elevation of barracks building, Station Lake Worth Inlet. Mascot is in foreground.

Figure 23. East (side) elevation of barracks building, Station Lake Worth Inlet.

Figure 24. North (back) elevation of barracks building, Station Lake Worth Inlet.

Figure 25. Close-up of window, east elevation of barracks building, Station Lake Worth Inlet.

Summary and Recommendations. The background research for Station Lake Worth Inlet suggested that the station had low potential for significant archeological sites, and our reconnaissance survey gave no indication of prehistoric or early historic occupation of the area. It is therefore the investigators' opinion that no further archeological investigations are needed at the facility. The historic structures reconnaissance, however, suggested that additional work should be conducted to determine whether the two buildings retain their integrity beneath the alterations and whether there are any historic associations with the buildings (Cordell 1984). According to Cordell, the date of the buildings and their association with the missile crisis make the sites potentially eligible for the National Register of Historic Places.

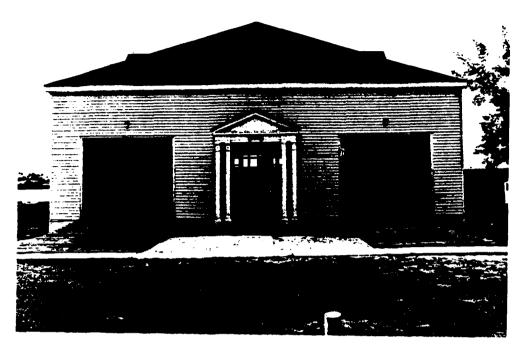
The boathouse, a white frame building with three dormers on the east and west sides, also maintains its basic character on the exterior although it has white vinyl siding (Figures 26-28). All other buildings on the property except for a small wooden paint house are constructed of prefabricated steel.

Figure 26. North (front) elevation of boathouse, Station Lake Worth Inlet.

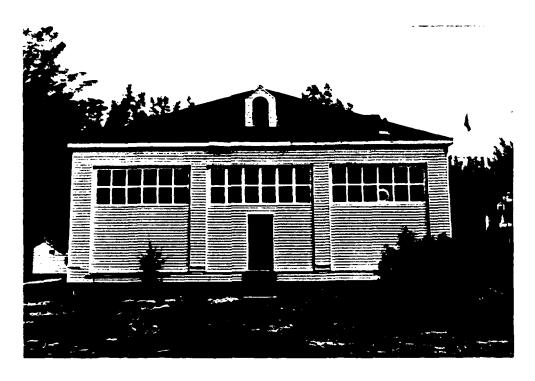
Figure 28. South (back) elevation of boathouse, Station Lake Worth Inlet.

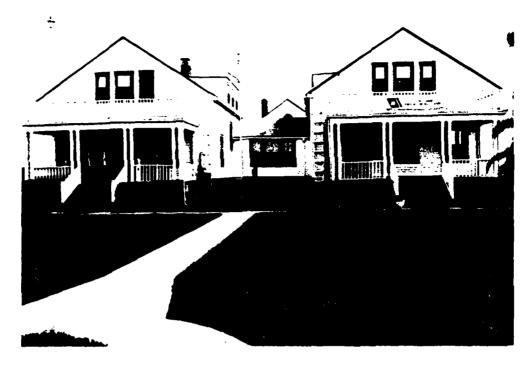
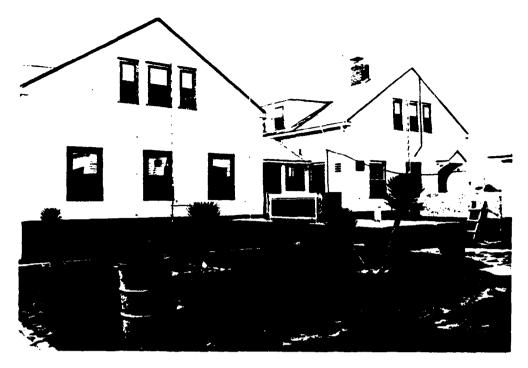
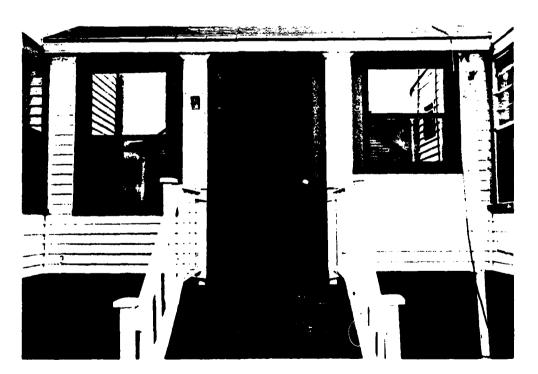
structures at the station are denoted in the General Plot Plan as the barracks building, boathouse, and garage. All three were originally wood frame, clapboard structures, and all have undergone moderate to extensive alterations. The exterior of the barracks building, which serves as the administrative headquarters as well as a living area, has been altered by the addition of vinyl siding, obtrusive air conditioning units, and solar panels. Aluminum windows have replaced the original wood windows, and new doors have replaced the original doors (Figures 34-37).

Figure 34. South (front) elevation of barracks building, Station Ponce de Leon Inlet.

Figure 35. West elevation of barracks building, Station Ponce de Leon Inlet.

Figure 36. North elevation of barracks building, Station Ponce de Leon Inlet. Oblique view from southwest.

Figure 37. Close-up of north elevation, showing "breezeway" of barracks building and newly installed windows, Station Ponce de Leon Inlet.

Summmary and Recommendations. Our archeological survey yielded no evidence for prehistoric or historic sites, and no further archeological investigations are recommended. The historic structures assessment suggested that while the structures may be of local interest, because of their extensive alterations they no longer satisfy the criteria for eligibility for listing on the National Register of Historic Places. No further historic structures documentation is required.

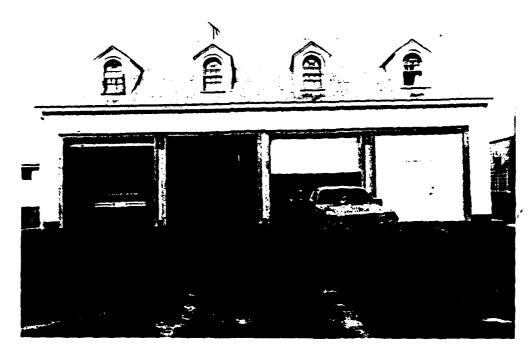
Figure 38. East (front) elevation of garage, Station Ponce de Leon Inlet.

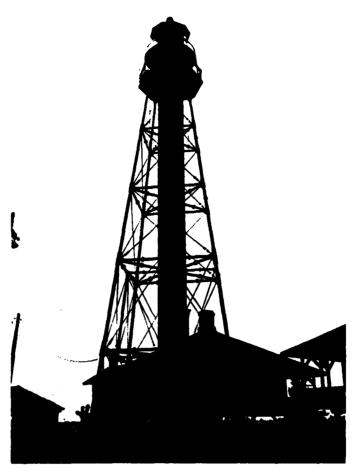
The lighthouse is a skeleton iron structure in the general shape of a frustrum or four-sided pyramid (Figures 43-44). A central cylinder enclosing a spiral stairway is used for reaching the lantern (Fryman 1973). The light has been automated and is still operational.

Figure 43. Sanibel Island Light with keeper's quarters and oil house.

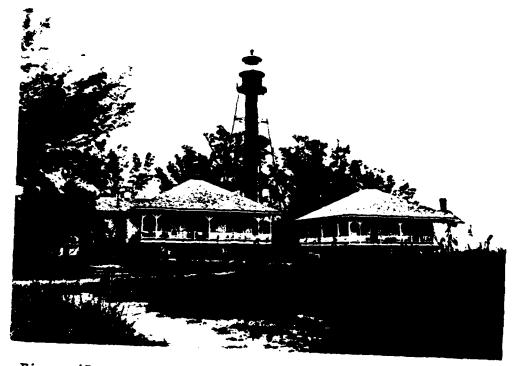
To the east of the lighthouse are two detached frame dwellings resting on well-braced iron columns (Figures 45-46). Constructed in 1884, these dwellings incorporate architectural features indigenous to the area such as wide verandas extending around the buildings on three sides, hipped roofs surmounted by a single chimney, and "L" extensions, which housed the original kitchens, on one side of each structure (Fryman 1973). The buildings appear to be relatively unmodified, but do have white gypsum siding on the exterior. The National Register nomination form states that both dwellings were attached to the lighthouse by a stairway. However, at the time of

Figure 45. View northeast of lighthouse and keeper's quarters, Sanibel.

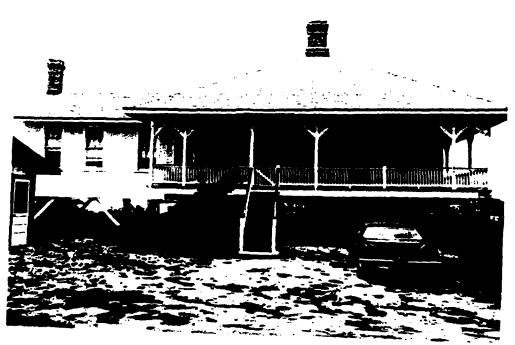
Figure 46. Front elevation of keeper's quarters #1, Sanibel.

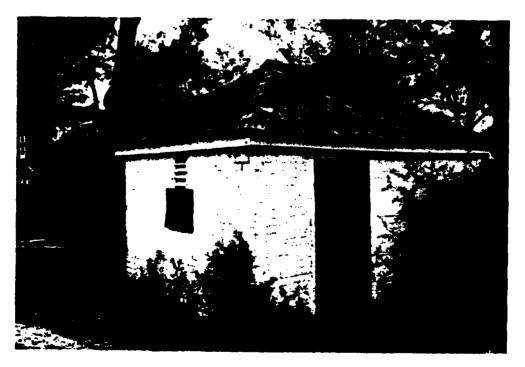
A fourth structure, not listed on the State file but contributing to the historic significance of the complex, is a small brick oil house constructed in 1884 and associated with the lighthouse (Figure 48). This structure was restored in 1976 by the Nicholas Meriwether Chapter of the National Society of Colonial Dames.

Figure 48. Oblique view of oil house, Sanibel.

Summary and Recommendations. Neither the archeological background research nor the reconnaissance survey gave any indication of significant archeological sites extant on the Coast Guard property, and no further survey is recommended. Since the lighthouse and keepers' quarters were already listed on the National Register, the historic structures assessment involved only a check on the information contained in the nomination forms. It is suggested that the nomination form be amended to include the oil house restored in 1976.

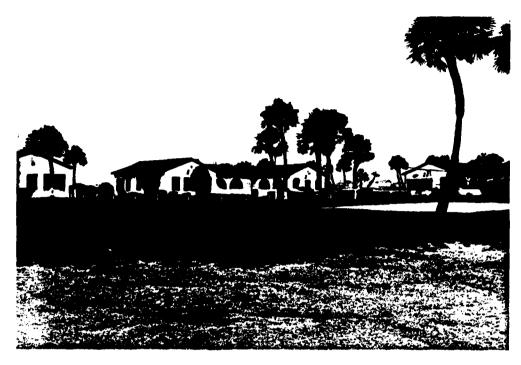
Historic Structures Documentation. The three mission-style buildings on the station date to 1936. These are the subsistence building, which houses the group commander's office, and two barracks buildings (the chief's quarters and crews' quarters). These three buildings, all of which appear to have suffered only minor

Figure 51. View of subsistence building and barracks, Station St. Petersburg.

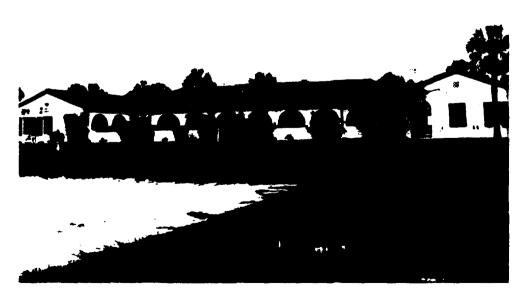
Figure 52. Front elevation of subsistence building, Station St. Petersburg.

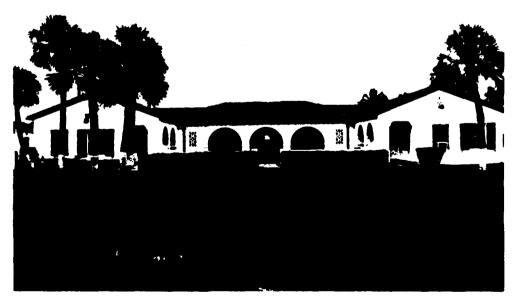
Figure 53. Front patio of subsistence building, Station St. Petersburg.

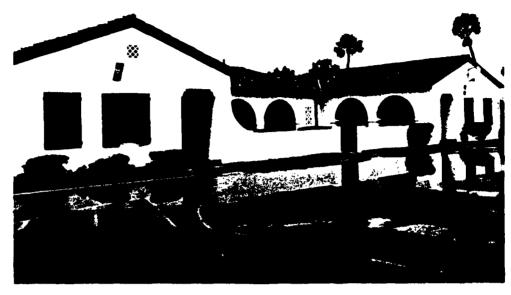
Figure 54. Front elevation of barracks (chief's quarters), Station St. Petersburg.

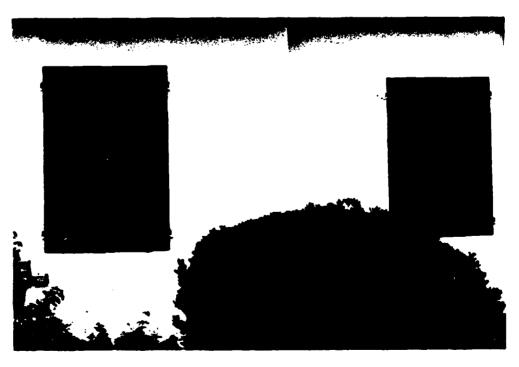
Figure 55. Oblique view of barracks (crews' quarters and public works building), Station St. Petersburg.
